# LOW-COST IMPROVEMENTS FOR TIRE PRODUCERS

*Tension Control delivers scrap reduction and improved product quality*

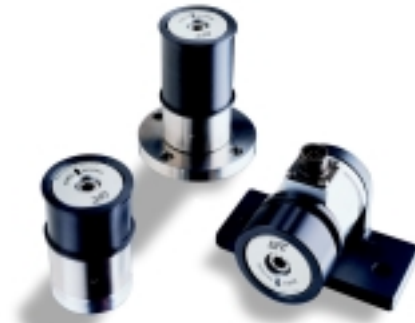
**RFA Tension Transducers**

RFA (Ribbon-Filament) tension transducers with tension amplifiers and 12 meters to monitor running tension continuously on each wire. Manual adjustments to the tensioning device are still made by the operators when deviations in wire tension are noted throughout the process.

The solution at one plant was to install tension transducers to accurately and simultaneously measure all wire tensions throughout a run. The results are consistent finished cord quality from reel to reel. The process uses 12

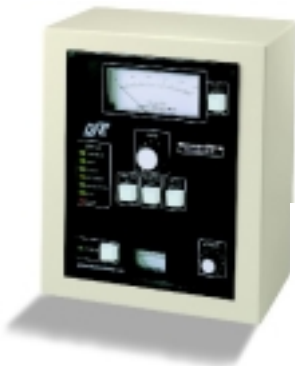
**SteadyWeb™** Automatic Tension Controller

To solve the problem, a pneumatic brake was used on the fabric liner unwind in conjunction with an automatic tension controller, and a 25 pound load-rated 14” Narrow Web

transducer measuring 12 pounds of tension. With this system, we were able to successfully reduce the process waste level from about 25% to less than 1%.
